**McGLELLAN AIR FORCE BASE**

**PREPARED BY:**  
Radian Corporation  
10395 Old Placerville Road  
Sacramento, California 95827

# OPERABLE UNIT B PRELIMINARY ASSESSMENT SUMMARY REPORT

**VOLUME III: APPENDICES C, D & E**

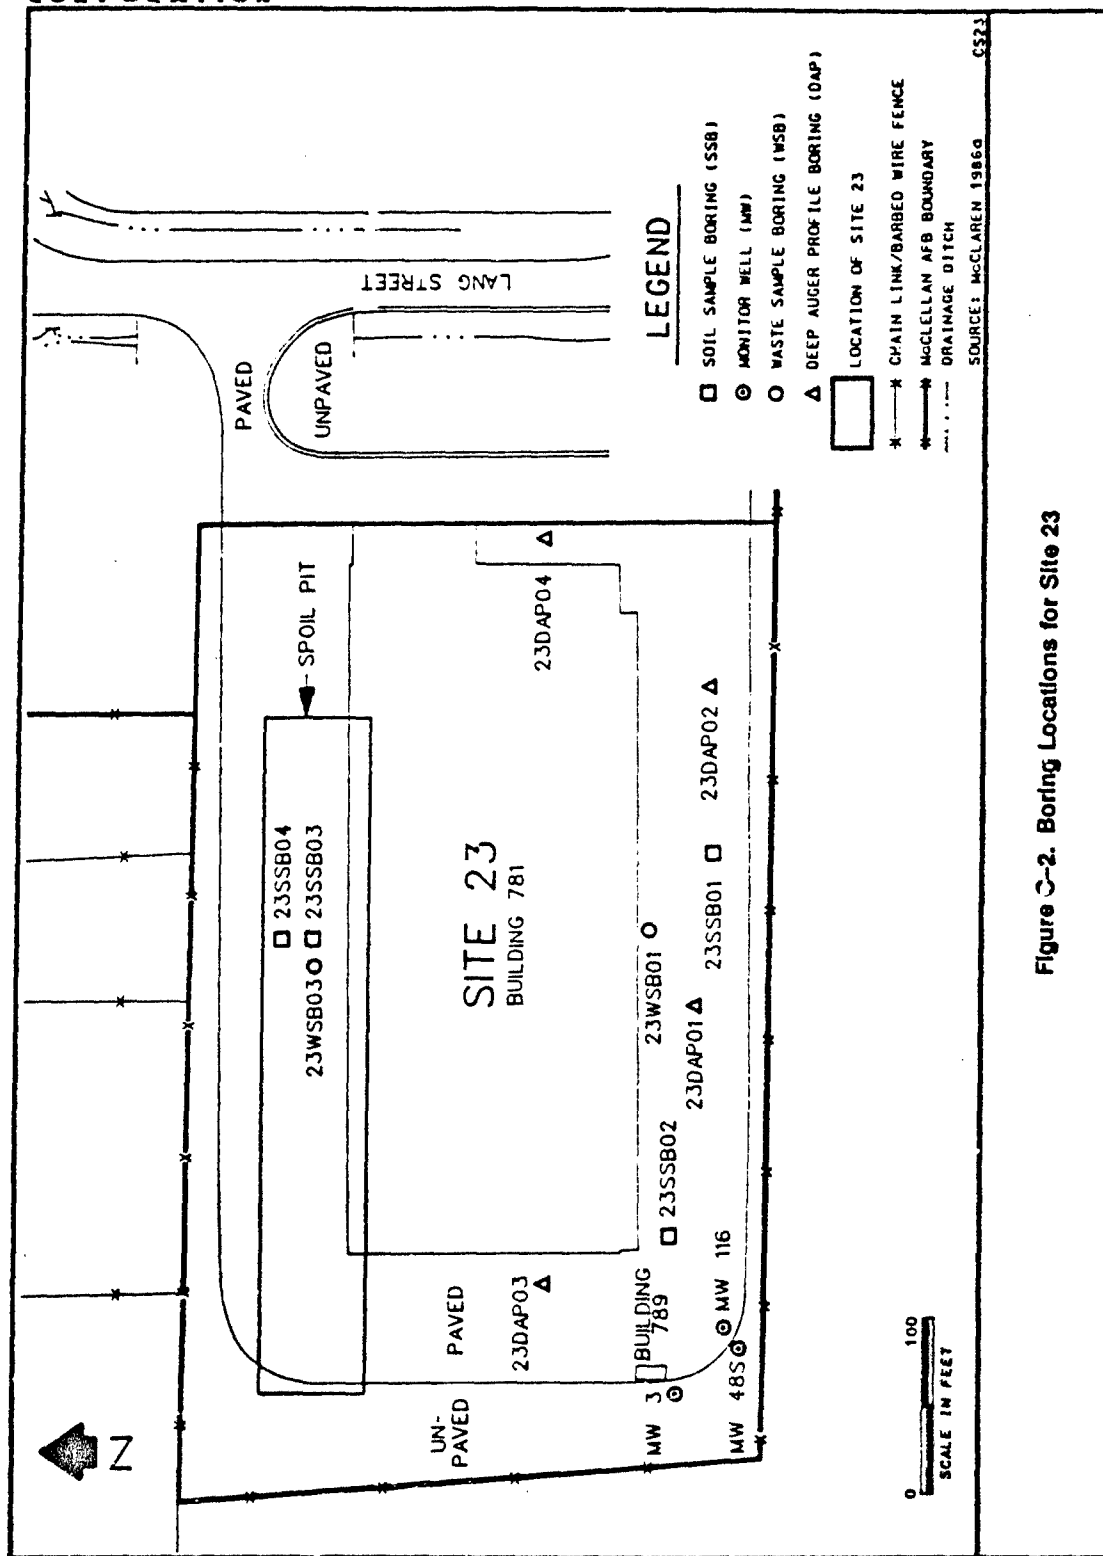
Figure C-2. Boring Locations for Site 23

Odors, discolored soil, or buried debris were noted in 7 of the 10 borings. The odors were described as "slight solvent/sewage" odors. Debris and discolored soil was found to 24 feet BGS.

Inspect the water lines in the vicinity of Site 23 to determine if they are leaking. If leaks are found, they should be repaired to reduce further transport of contaminants in the soil. Collect and analyze additional soil samples to further characterize the extent of contamination.

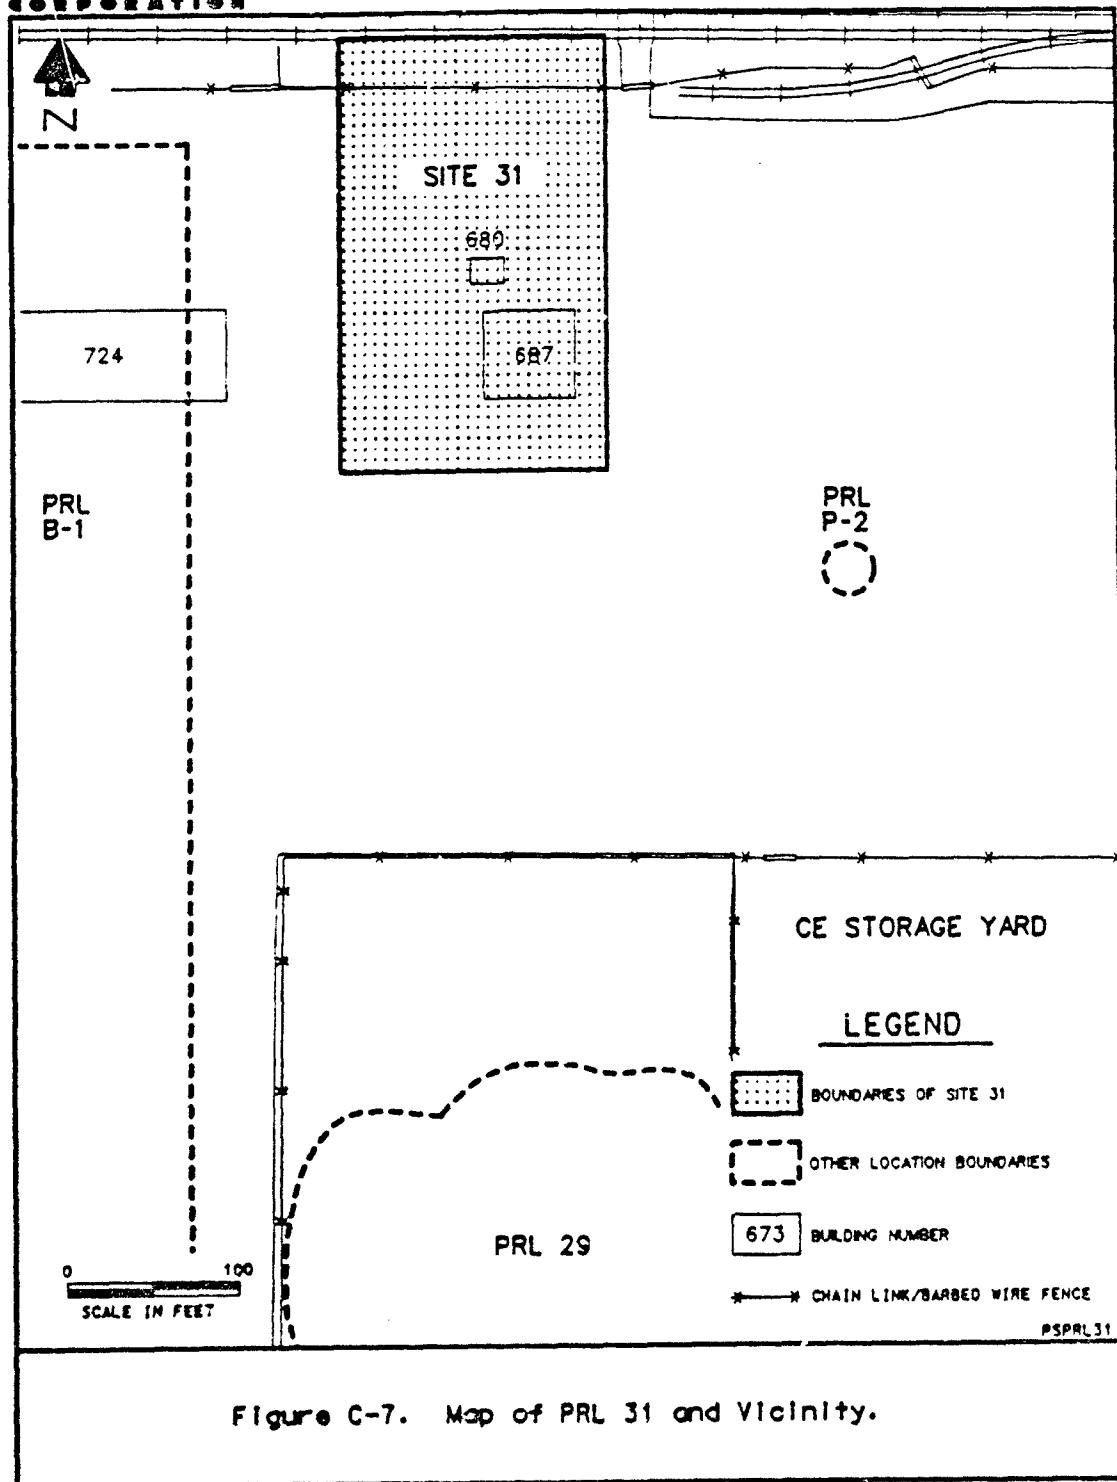
Figure C-7. Map of PRL 31 and Vicinity.

Discolored soil was noted at 2 to 3 feet BGS in Borings 31WSB02, 31WSB15, and 31SAP18.  
Odors were noted in Borings 31SAP17 and 31SAP18 at 2 to 3 feet BGS.

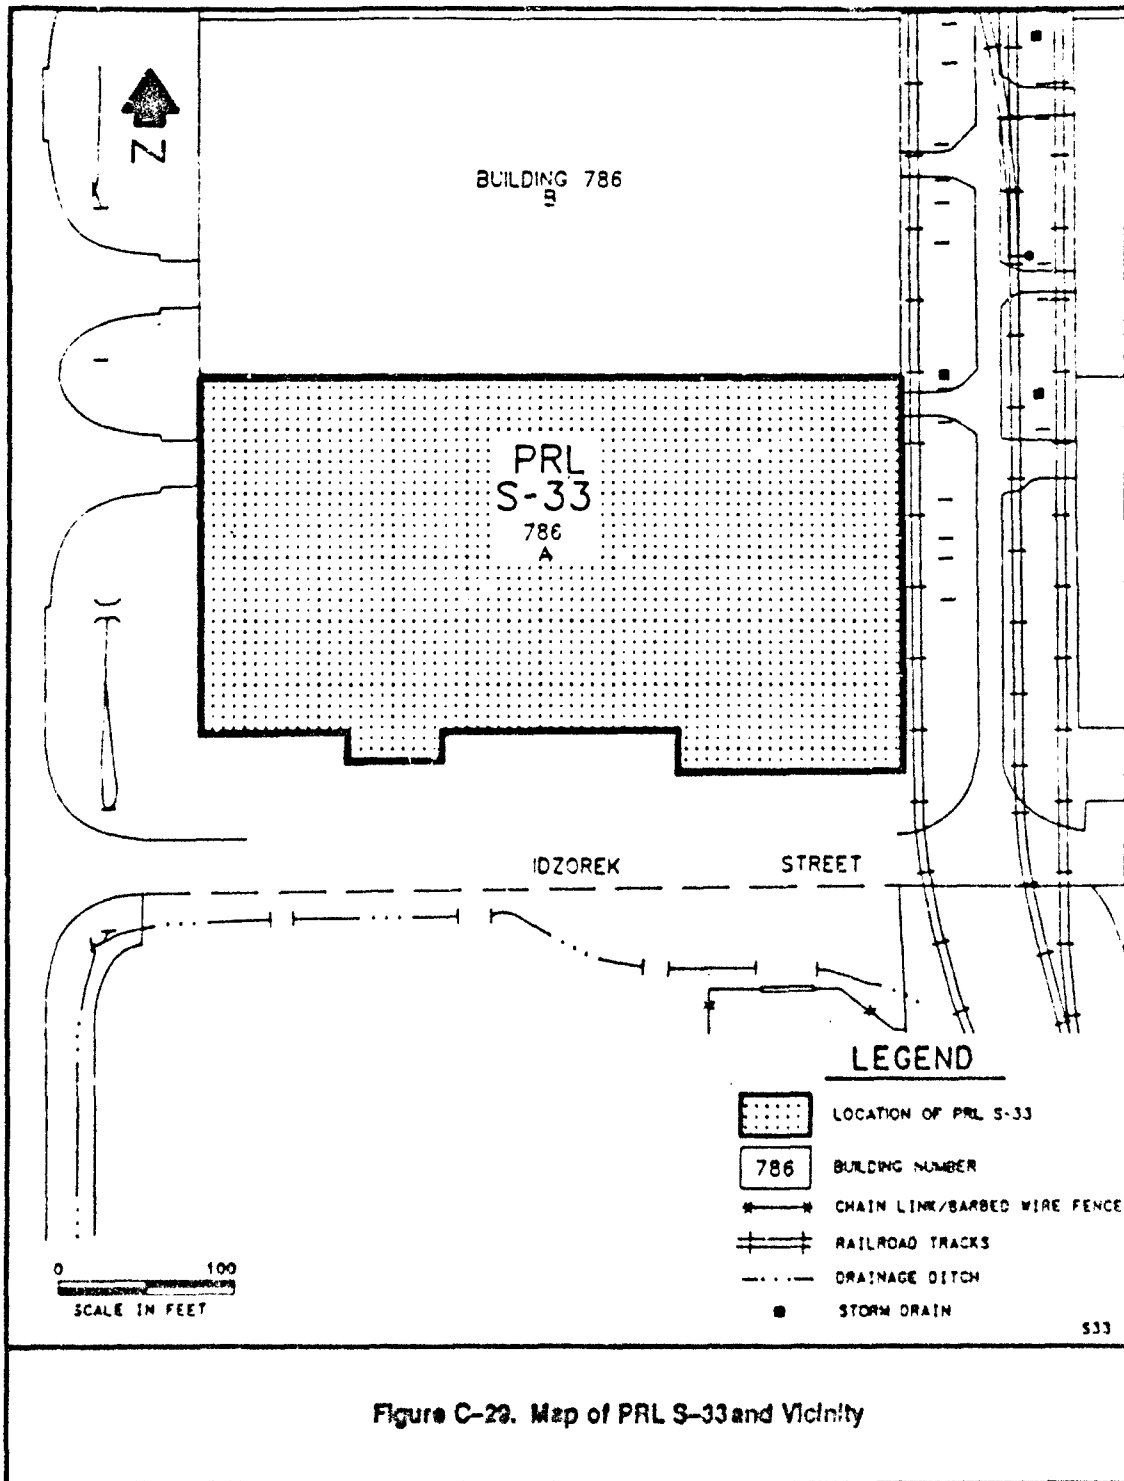
Figure C-23. Map of PRL S-33 and Vicinity

Building 786A is presently used for depot stock control. The building contains offices and a boiler room, and is used for furniture storage. Radian's site inspection was conducted on 28 April 1989. Cracks in the foundation of the building were noted during the inspection.

Screen cracks in foundation and southern and western loading docks for organic vapors. Collect and analyze soil samples if warranted by the screening results.
